Condenser Tubes in Thermal Power Plants Issues and Solutions

ICCI 2014 April 24, 2014

Presented by Dan Janikowski +1 262 642 8365 E-Mail: djanikowski@plymouth.com

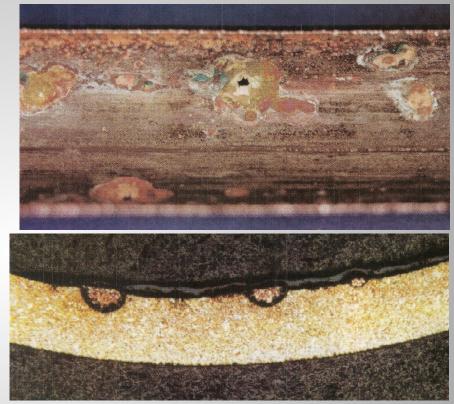
Dealloying

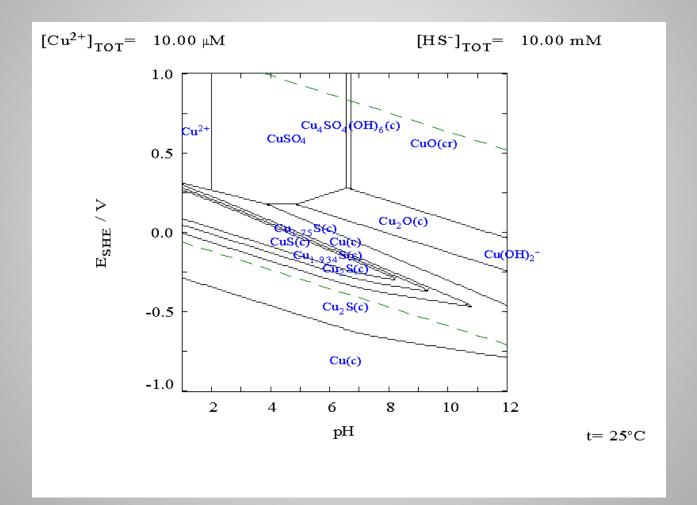
Add a Bit of H₂S

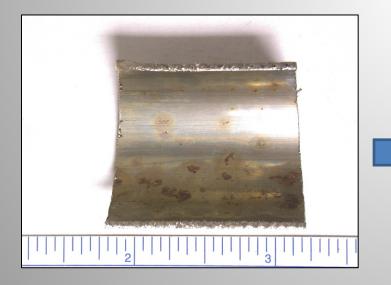
Galvanic Corrosion

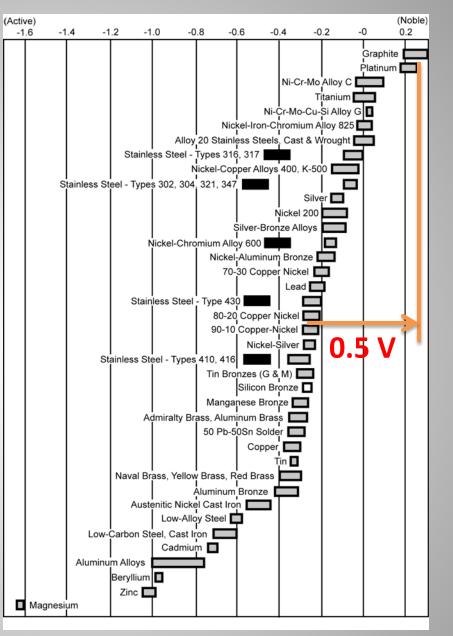
Galvanic Attack

- In area of graphitic char, the Cu/Ni becomes the sacrificial anode!
- It's crucial to make sure that Cu alloy is clean

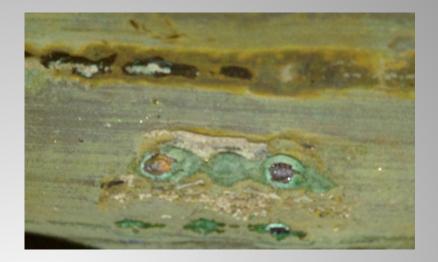
MIC Attack

Copper Alloys

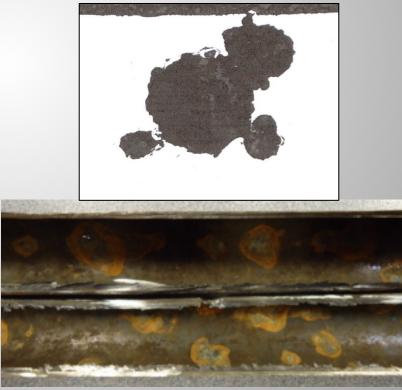
300 Series

Type 439

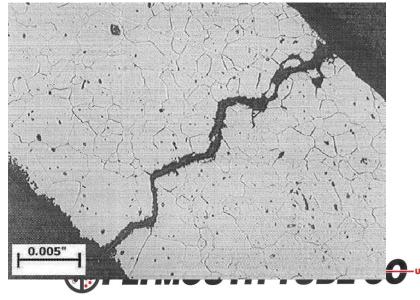
Hydrogen Embrittlement – Super-Ferritic Stainless

- Can occur quite suddenly under shock condition
- Occurs near H₂ source which is usually at end of tube at rolled transition joint.
- Usually at outer tubesheet edge near anode

- In most cases easy to prevent!
 - Keep impressed current system voltage less negative than -750 mv.
 - Don't use Mg based sacrificial anodes
- Super-ferritic embrittlement is reversible
 - Once discovered, eliminate source and ductility will return
- Ti embrittlement is not reversible
 - 8 entire condensers have been replaced.

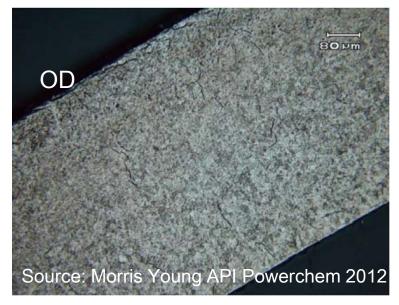
Hydrogen Embrittlement – Titanium

- Growth in Ti is gradual
- Located mostly near source but area is more extended
- If cathodically induced, usually tubesheets are damaged at same time

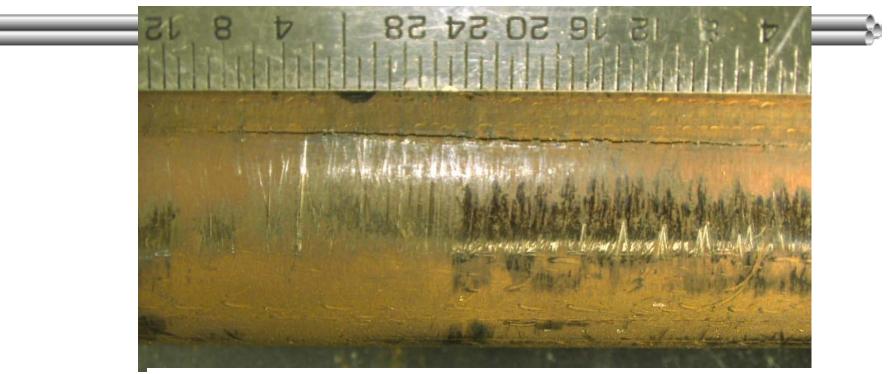
New Vibration Failure Mode

- Has been identified in 4 nuclear plants
- Random locations in the bundle
- Always associated with a longitudinal groove such as a scratch or weld depression

- Believed to be high cycle fatigue from "whirling" motion
 - Tube may be "ovaling" during whirl
- So far has only occurred to Ti
 - Ti has a low modulus and fatigue limit
 - May be accentuated by anisotropy precaution in ASME Section II Part D para. A454

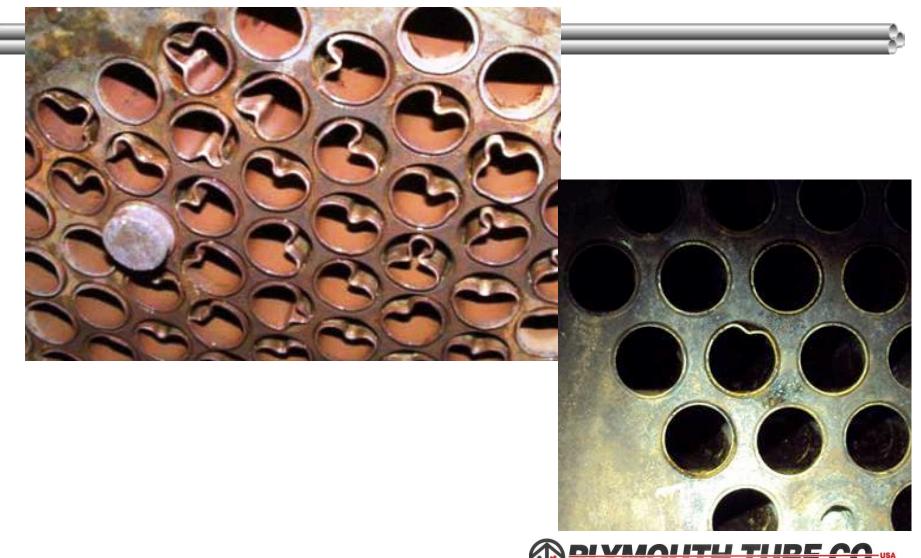
Cleaning Challenges

- How to avoid?
 - Turn off wand before exiting and don't turn on until it's into tube!
 - Use other cleaning methods

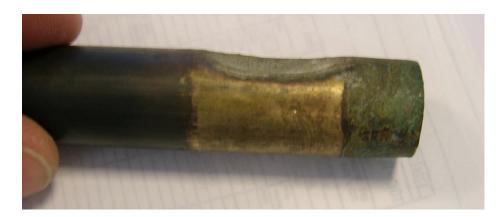
Cleaning Challenges

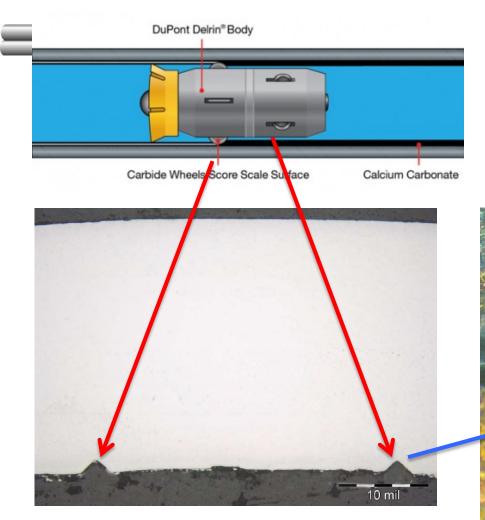
Cleaning Challenges

<u>Two Ti tubed plants</u> <u>now having failures</u> <u>from ID grooves</u>
