CORROSION 91

MICROBIOLOGICALLY INFLUENCED CORROSION TESTING OF WELDED STAINLESS ALLOYS FOR NUCLEAR POWER PLANT SERVICE WATER SYSTEMS

Jeffery R. Kearns
Allegheny Ludlum Corporation
Brackenridge, PA 15014

Susan W. Borenstein
Pacific Gas and Electric, Co.
One California St., San Francisco, CA 94106

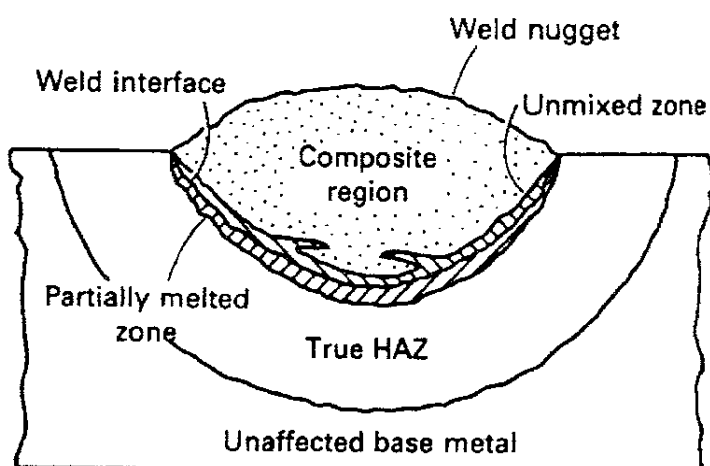
Figure 1—Schematic illustration showing the regions of a heterogeneous weld. ²⁷

Weld microstructure. The regions within a weld can be described in the following terms, as illustrated in Figure 1:²⁷

- Composite Zone-The bulk of the weld bead consisting of filler metal that has been mechanically mixed with melted base metal and, consequently, altered in composition.
- Unmixed Zone-The zone at the outer edge of the weld metal consisting of base metal that has melted but not mechanically mixed with filler metal prior to solidification.
- Weld Interface-The surface bounding the region of base metal that had completely melted during welding as characterized by a definite solidification substructure.
- Partially Melted Zone-The portion of the base metal located just outside the weld interface within which the degree of melting ranges from 0 to 100%.
- True Heat-Affected Zone (HAZ)-The portion of the base metal within which microstructural changes have occurred but in the absence of melting.

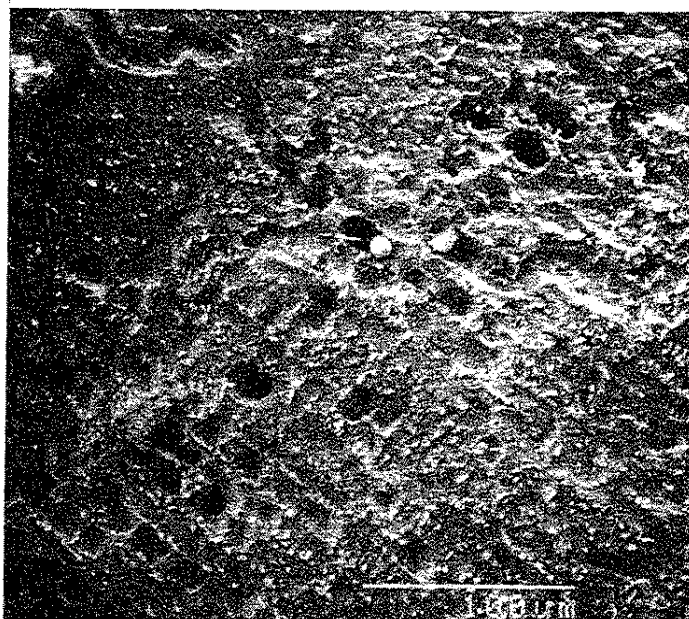
Figure 2—Localized corrosion at inter-dendritic regions of a ER 308L weld in a Type 304L pipe exposed for 1 year to flowing well water.

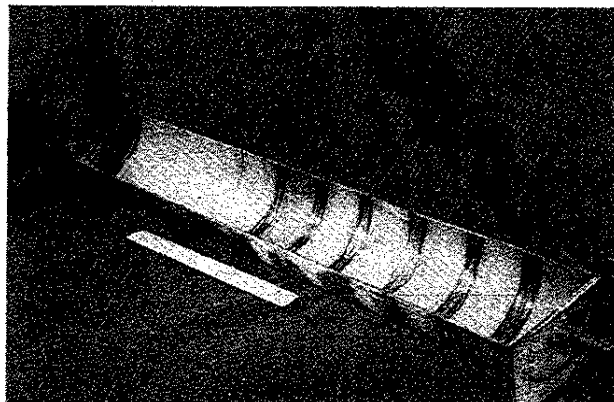
Figure 3—"MIC troughs" consisting of Type 304L pipe with nine circumferential welds.

A total of nine multi-pass circumferential welds were made in each pipe. Various filler metals and weld metal inserts were used in either a manual gas tungsten-arc welding (GTAW) or an automated gas metal-arc welding (GMAW) process. Certain sub-assemblies in each pipe were post-weld annealed and pickled and others were just pickled prior to final assembly. All of the pipe sections were split longitudinally in half, end-capped and fitted with inlet and outlet lines to form "troughs" (Figure 3). The troughs were tightly fitted with metal lids. In this way, the ID surface of the pipe could be observed during exposure without interrupting the flow of water through the pipe. Defective welds were also prepared in AL-6XN pipe for comparison. The defective sections had a single weld that either had been incompletely penetrated, was heat tinted, or had less than the minimum weld gap.

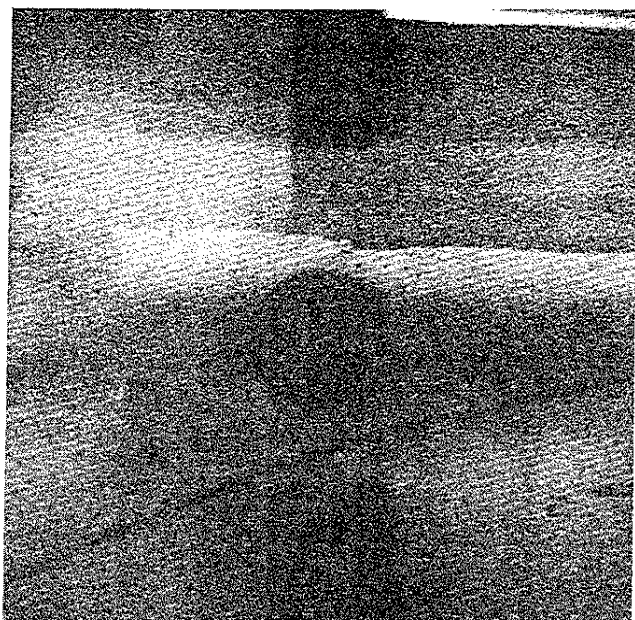
Figure 4—Tubercle formed Type 304L pipe after two weeks of exposure to flowing well water.

The appearance, smell and feel of a biomass deposit can be useful indicators of underlying MIC.⁴¹ The troughs were examined daily for approximately the first month of the exposure. After two weeks, reddish-brown deposits/tubercles were observed over certain welds (Figure 4) and taken as an indication of iron-oxidizing bacteria.⁴² Rust-colored streaks and ring patterns surrounded pitted areas in both the Type 304L (Figure 5) and 316 troughs. The biomass was most concentrated at the bottom of the horizontal pipe.

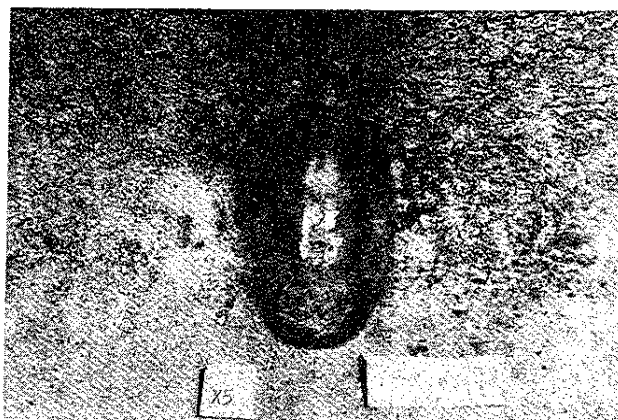
Figure 5—Rust-colored streaks and ring patterns surrounding a pitted area in a Type 304L pipe exposed for 1 year to flowing well water.

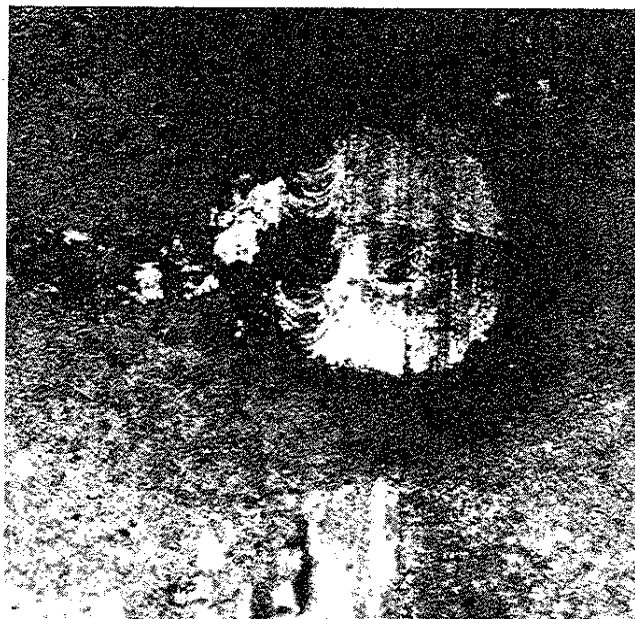
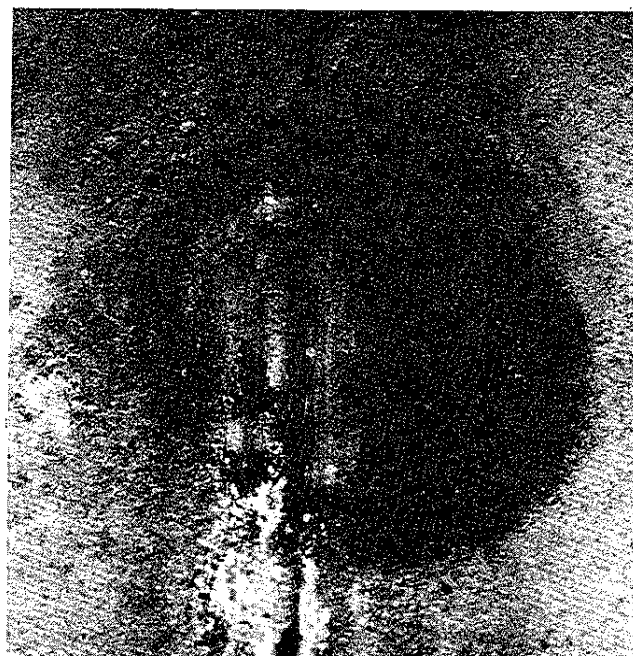
Figure 6—Large cavernous pits formed under tubercles at welds in both Type 304L (A) and Type 316L (B) pipes. The pipes had been exposed for 1 year to flowing well water.

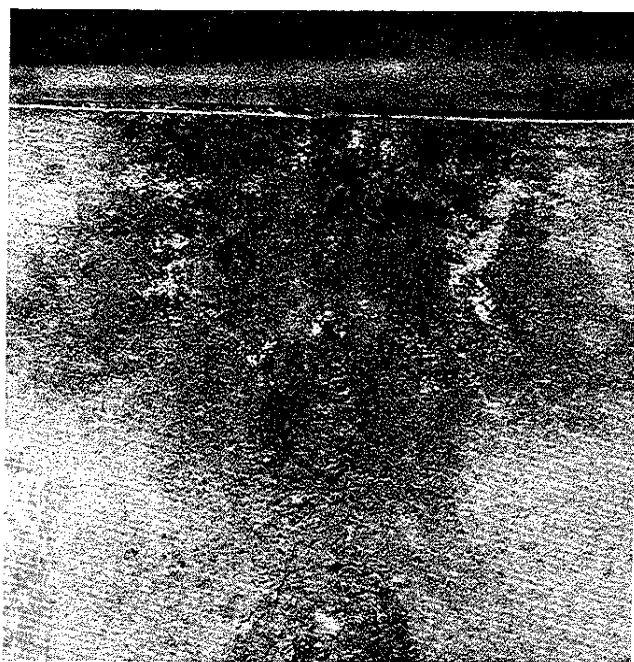
Figure 7—Corroded as-deposited weldments and base metal areas near the water line of Type 304L pipe exposed for 1 year to flowing well water.

The Type 304L and 316L troughs were destructively examined after one year of exposure. Small patches of rusty corrosion product discolored the as-deposited weldments and base metal areas particularly near the water line (Figure 7). Approximately a dozen small isolated areas of open, shallow pits were observed away from the weldments on the base metal of certain sections that had not been heat treated. These pits were generally very close to the water line.

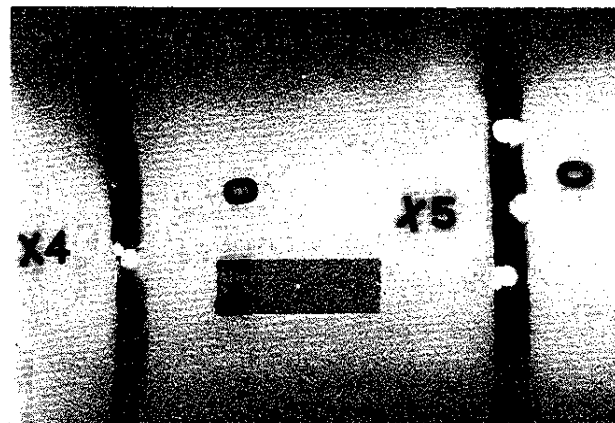
Figure 8—Radiograph of Type 304L pipe exposed for 1 year to flowing well water showing extensive pitting at and adjacent to ER 308L weld.

were radiographed before and after exposure. Extensive pitting was found at or adjacent to almost all of the welds in the Type 304L and 316L troughs that had not received heat treatment (Figure 8). No pits were found on the solution annealed weldments.

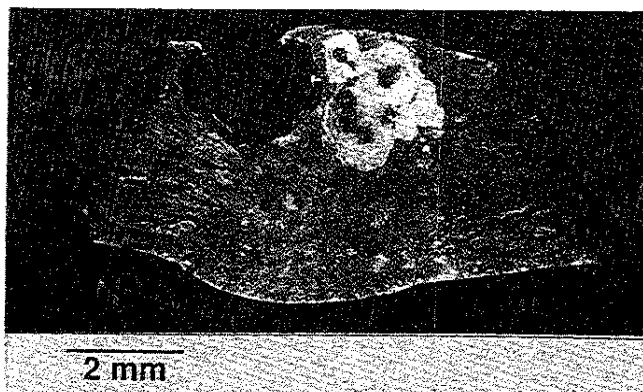
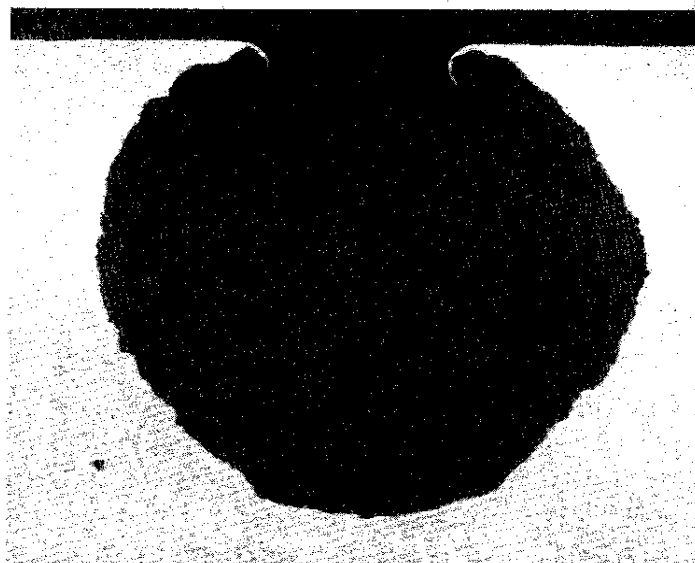
Figure 9—Comparison of MIC and chloride pit morphologies: The pit in "A" occurred in a Type 304L pipe welded with ER 308L filler and the pit in "B" occurred in commercially produced Type 304 strip exposed to a laboratory NaCl solution. (Electrolytic 10% oxalic acid etch).

Metallographic Examination. Microbially influenced pitting has the morphology of a "classic" chloride pit in that a large pear-shaped void forms below a small break in the surface Figure 9. The weldment shown in Figure 9A was fabricated of Type 304L base metal using ER 308L weld filler and the pit shown in Figure 9B is of commercial annealed and pickled Type 304 exposed to a laboratory NaCl solution. The preferential etching of the weld in Figure 9A indicates that the as-welded ER 308L weld deposit behaved anodically to the Type 304 base metal.

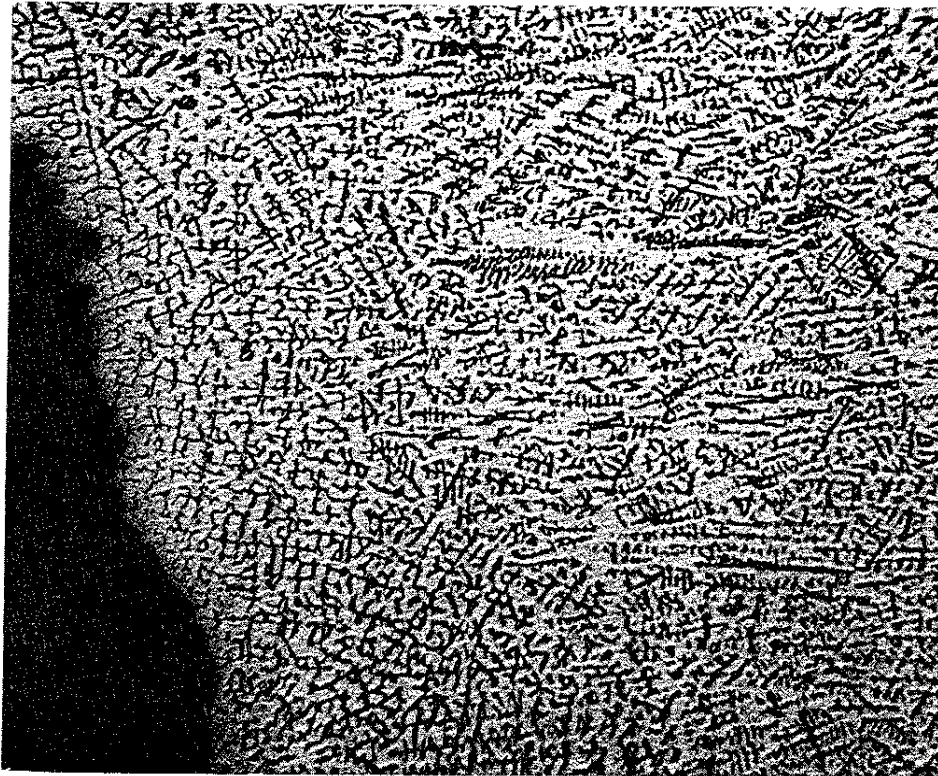
Figure 10—Photomicrograph showing preferential attack of ferrite in ER 308L weld. (Electrolytic 10% oxalic acid etch).

Metallographic and SEM examinations revealed that the attack initiated with the preferential dissolution of delta-ferrite and then both phases became active (Figure 10). Cases of preferential MIC of either and both delta ferrite and austenite have been reported.⁴² This would indicate that the localized conditions under a biofilm can vary greatly. Delta-ferrite is selectively attacked in duplex weld microstructures in reducing acids⁴³ while austenite is preferentially attacked in oxidizing chloride solutions. Both phases are attacked under other conditions.⁴⁴
