WORLD STAINLESS STEEL

Volume 19, March 2007 Reprint

Cooling water chemistry - friend or foe

Daniel S. Janikowski, William J. Kubik, Plymouth Tube, USA

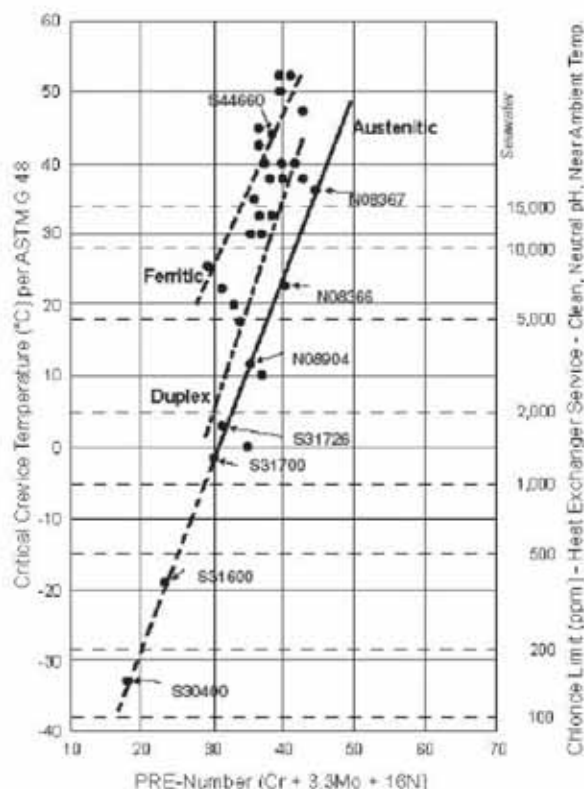
Kovack and Redmond³ studied this relationship further and developed three relatively parallel relationships depending upon crystal structure. The ferritics were found to have significantly greater crevice corrosion resistance than the austenitics for a similar PREn. Understandably, the duplex grades fell in between. Janikowski⁴, and Tverberg and Blessman⁵ used this relationship to develop a tool to determine the maximum chloride content that should be used for each alloy. This is presented on the right hand axis of Figure 2.

Rockel² determined that the additions that provide the chloride resistance in stainless steels are chromium, molybdenum, and nitrogen. This led to the development of the Pitting Resistance Equivalent number, PREn which is defined as follows:

$$\text{PREn} = \% \text{Cr} + (3.3 \times \% \text{Mo}) + (16 \times \% \text{N})$$
