Corrosion Testing of Metals – Is It Needed?

**The 35th Electric Utility Chemistry Workshop
At The University of Illinois**

**June 2-4, 2015
Hawthorn Suites by Wyndham
Champaign, Illinois**

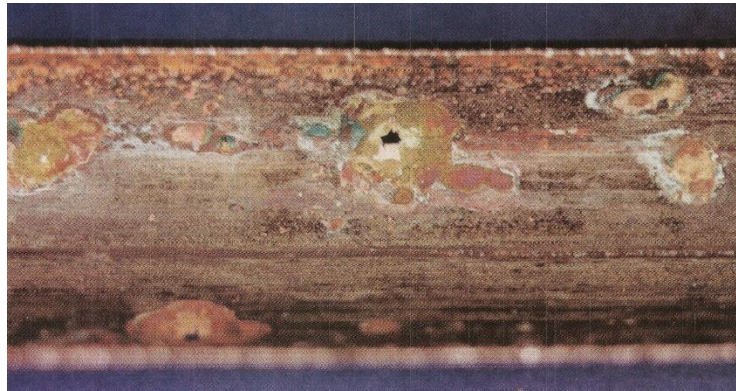
Figure 1. ID surface of actively pitting Admiralty brass tubing.

1. Pitting and crevice corrosion: These are some of the most common mechanisms causing failure of copper based tubing. Through-wall pitting can be seen in the Admiralty brass tube in Figure 1. Although most of the surface on this tube has different shades of brown which indicate some degree of corrosion product or passivation, shiny copper colored areas are indicative of actively corroding

regions that have not repassivated. Pitting and crevice occur when one location loses passivation by contamination, attack by a corrosive media, or conversion of the patina to another less protective compound.

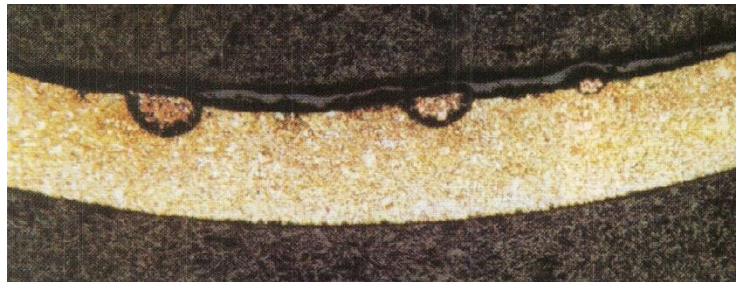
Figure 2. Dealloying (denickelification) of 90-10 Cu-Ni tubing

2. Dealloying: Dealloying is unique to copper alloys. It is the result of one alloying component dissolving from the metal at an area where local attack is occurring. For example, on Admiralty or aluminum brass, zinc may diffuse through the metal and preferentially dissolve into the water. On copper- nickel alloys, nickel commonly leaves the alloy. A porous copper rich material remains (Figure 2) which has little or no integrity. Although often identified as a separate failure mechanism, it is quite common when pitting or crevice corrosion is present.

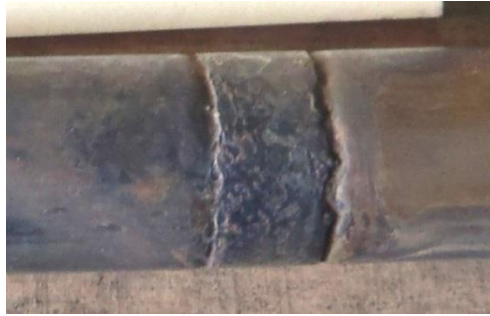
Figure 3. Ammonia grooving of Admiralty brass tubing

3. Ammonia grooving: This mechanism is common on the outer surface of Admiralty or aluminum brass steam surface condensers. It occurs in regions of ammonia concentration. This is often in the air removal zone as the steam drives the non-condensable ammonia to this area. Mixed with water, ammonia can dissolve the protective patina. The corrosion rates are highly accentuated along the support plates as they channel the “ammoniated” condensate to the hot well. The flushing action removes the oxide as fast as it reforms accelerating the attack. This creates grooves on each side of the support plates in those regions. The tube shown in Figure 3 has less than 18 months of service. Although not immune, copper nickel alloys are much more resistant.

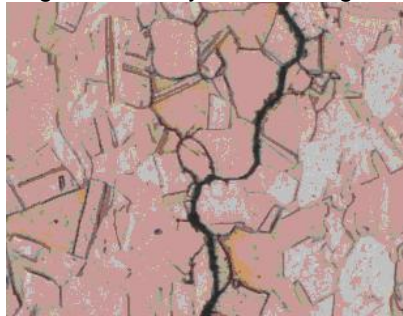
Figure 4. Intergranular ammonia stress corrosion cracking of copper alloy.

4. Stress-Corrosion Cracking: Often associated with ammonia grooving is ammonia driven stress-corrosion cracking. When the tubing has higher residual stresses, intergranular (the cracks that propagate around the individual grains)

may occur at regions of high ammonia concentrations. An example of this is evident in Figure 4.

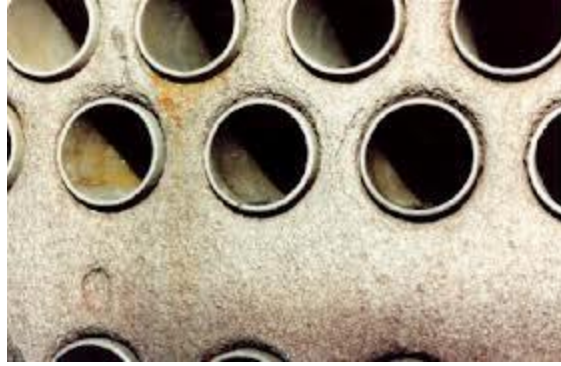
Figure 5 Localized galvanic attack immediately adjacent to stainless steel tubing.

6. Galvanic Corrosion – Although many corrosion mechanisms like pitting and crevice corrosion include a galvanic component, copper alloys are often in situations where they are attacked galvanically. The alloys are anodic to titanium, nickel alloys, and stainless steels so that when they are galvanically coupled to these metals, they dissolve. Figure 5 shows localized attack of the tubesheet immediately adjacent to the stainless steel tubes. Current density is highest next to the tubes explaining the “grooving” effect. However, a number of recent failures related to a different “couple” have created by lack of care during the copper alloy tube manufacturing. These failures were first noticed in several nuclear exchangers replaced with like-for-like tube replacements. These failures occurred rapidly, usually within several months. They were due to random pitting throughout the length of the tubing. When unused spare tubing was examined, gray stains were often found similar to the pitting pattern. A similar pattern is evident in Figure 6 of some copper-nickel condenser tubing that failure in a similar manner and time frame.

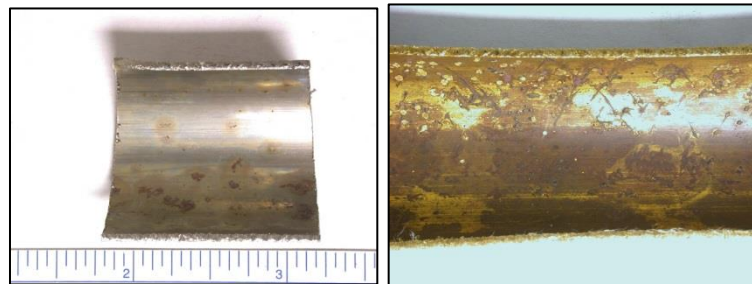
Figure 6. ID surfaces of Cu-Ni tubing. Gray to brown stains were evident in new tubes on the left. These stains were the precursor to the pitting failure seen in the picture on the right.

These stains are caused by residual graphitic char resulting from the manufacturing process. The char can be developed by two situations; 1. Heat treating utilizing a natural gas based reducing environment which is controlled in a “too rich” condition, and; 2. Insufficient removal of lubricants after the drawing operation resulted in the degradation of the lubricant during the annealing process. As graphite is electrically conductive, it often is used as one leg of a galvanic couple. Graphite is also considered one of the most noble materials. When coupled with copper alloys, it can generate approximately a 0.5 volt difference. The copper alloy adjacent to the high graphite concentration sacrificially corrodes. In high conductivity water, the corrosion rates can be quite high.

Unfortunately, graphite cannot be readily dissolved in common pickling solutions. Therefore, pickling or passivation may not be a process solution to this problem. An aggressive mechanical polish is the only effective method known by the author. Unfortunately, this process may not be available for tube diameters below 1” OD.

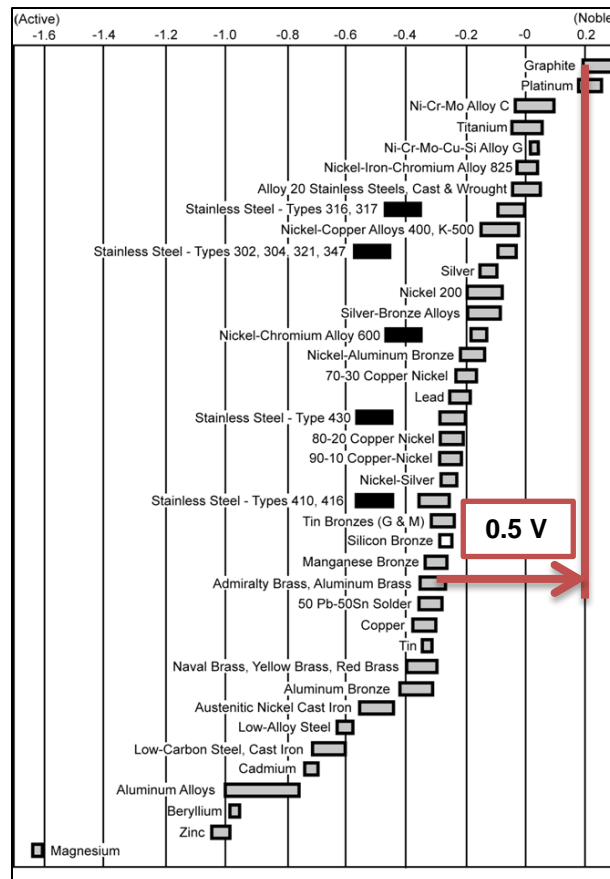
Figure 7. Galvanic series for seawater. Copper alloys are approximately 0.5 volts more anodic than graphite making them very susceptible to attack in conductive waters when graphite is present.

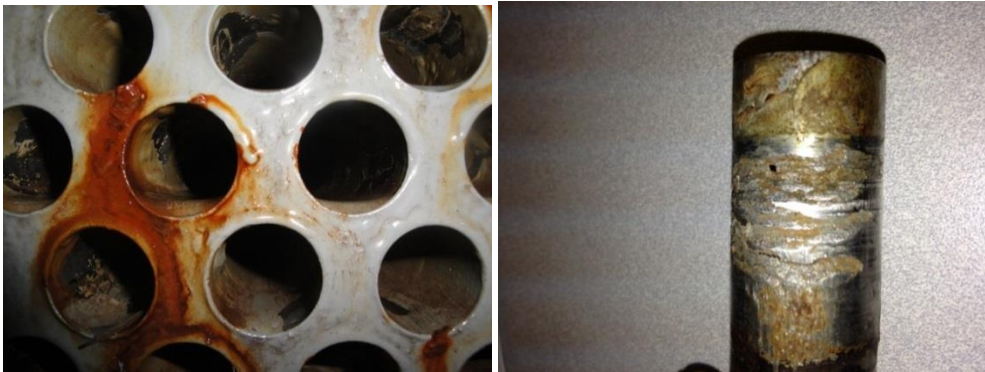
Figure 8. Crevice corrosion of a rolled tube-to-tubesheet joint (left) and the damage caused to the tube surface while in the joint (right).

depassivate initiating the corrosion cell. A discussion on chloride levels vs. alloy can be reviewed in reference 2. Tight crevices can become very aggressive, believed to be due to their ability to trap the solutions and concentrate chlorides, while developing very low pH values. A common tight crevice example is a rolled tube-to-tubesheet joint. Figure 8 shows an example of the potential damage. Aggressive crevices are produced in a numerous additional situations including scaling, gasketed seals, mechanical joints, and even under certain paints (see Figure 9). The “OK” on the alloy 416 CW pump shaft is the result of crevice corrosion from the marking paint applied by the final inspector during assembly.

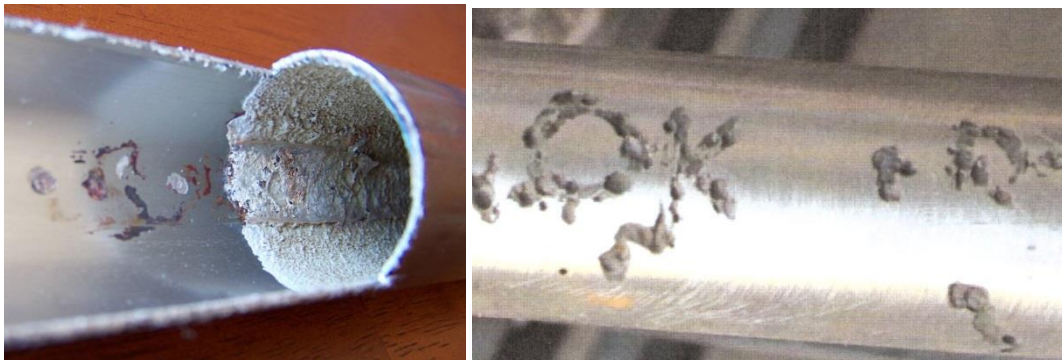
Figure 9. Examples of crevice corrosion in a scaled stainless steel tube and on an alloy 416 cooling water pump shaft.

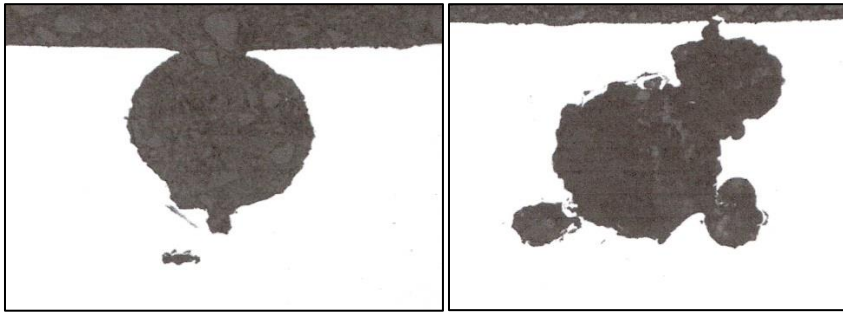
Figure 10 Examples of round and multi-round small opening pits common with Mn related MIC attack of stainless steels.

theory is that the *Gallionella* bacteria assist in the oxidation of Mn^{+2} ions in the water to form a layer of MnO_2 . As little as 20 ppb Mn ion can be sufficient for this occur. This layer acts as a crevice. Chlorination further oxidizes the layer to form a permanganate releasing a hydrogen ion. The hydrogen reacts with the free chloride ion to create hydrochloric acid depassivating the stainless similar to that with simple chloride attack without the presence of the bacteria. The damage is often the round, or multi-round tunneling cavities with a small opening on the surface exposed to the water (Figure 10).

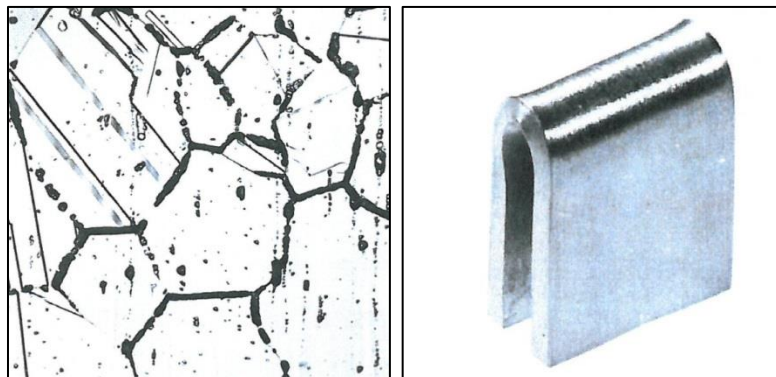
Figure 10. The two steps of an intergranular corrosion test. The microstructure on the left shows some ditching but is not considered rejectionable. When no grain is completely surrounded by ditching, the material is considered acceptable and no further testing is required. The bend test on the right is the second step if the first fails.

Intergranular corrosion testing is often performed in two steps. The first step is an acceptance step that allows etching a polished sample with oxalic acid and looking for “ditching” at the grain boundaries. An example of an acceptable microstructure is in Figure 10. In this figure, although ditching is evident, no grain is completely surrounded making the lot acceptable. If a grain is completely surrounded, then the material is tested in accordance with the second step. The most common next step is Practice E, where the sample is placed into a boiling copper, copper sulfate, 16% sulfuric acid solution for 15 hours and then bent over itself. If no cracking is evident, the material is accepted.

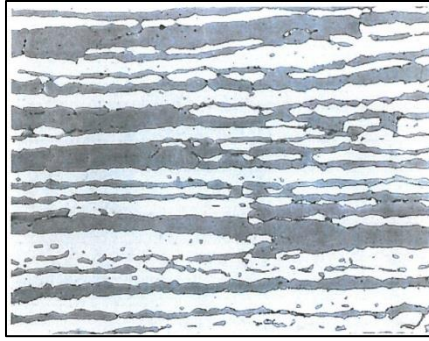
Figure 11. Grain boundaries may be difficult to identify in duplex stainless steel.

The use of duplex stainless steels is becoming more common in many industries and the alloys are slowly being adopted into the power industry. Duplex alloys respond to improper heat treatment quite differently than either austenitic or ferritic alloys. Instead, the alloys tend to form secondary phases which can have impact on the corrosion resistance. These compounds are formed from Cr and Mo, resulting in less available for corrosion resistance. For example, Figure 11 is a microstructure of a duplex stainless steel that has formed a few of the intermetallic particles.

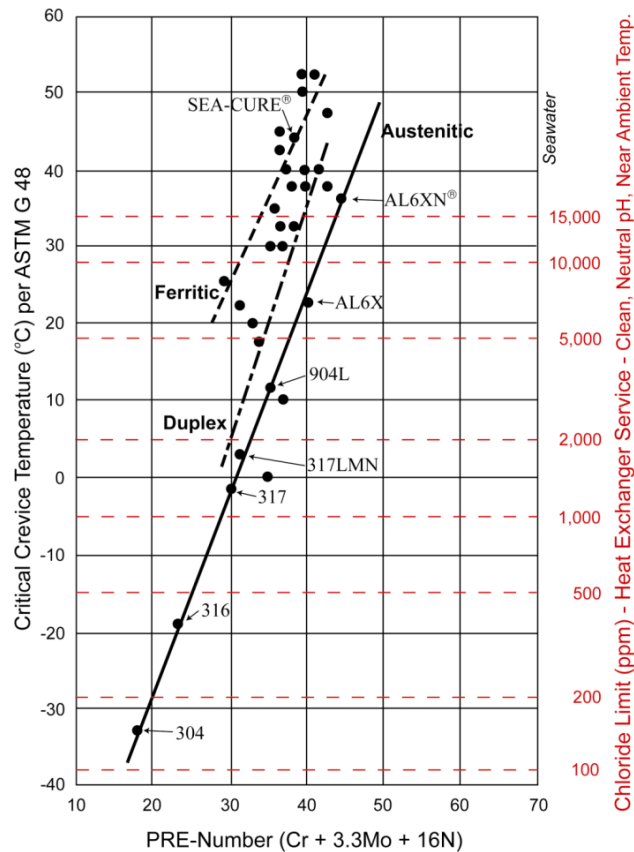
Figure 11. Impact of G-48 test temperature vs. corrosion resistance. Ref. 2

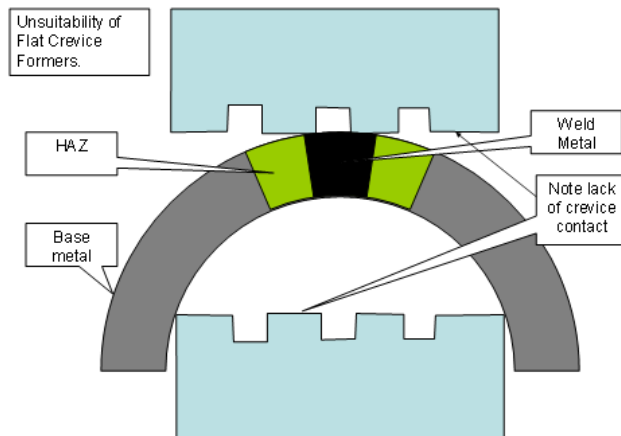
Figure 12. Schematic of the traditional flat crevice corrosion fixture attempting to test a tubular product. Thanks to John Grubb from ATI for supplying the drawing.

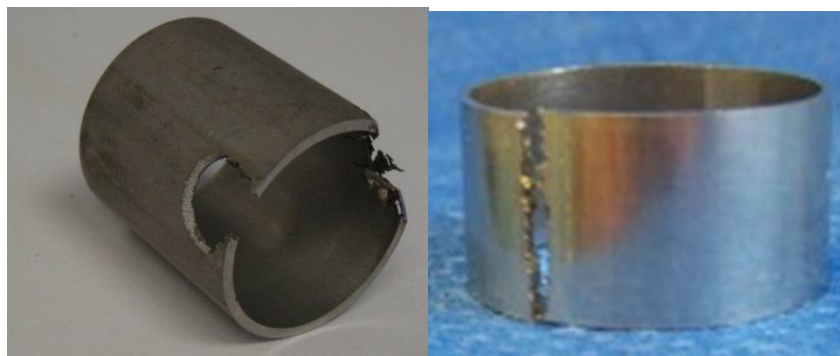
Figure 13 G-48 Method C failures of S44660 (left) and S32050 (right)

Although the criteria for G48 Method C specifies that pitting deeper than 0.001” is unacceptable, substandard tubing rarely displays only minor pitting. Figure 13 shows failures of improperly heat treated super-ferritic S44660 and super-austenitic S32050.

In this test, when the ferritic alloys fail, they often have only one or two “massive “ pits. The pitting is often independent of the weld location. The super-austenitic S32050 on the right, the center of the weld has dissolved. This tube was manufactured an induction heat treatment following the welding and cold working, which is now very common globally. The higher nickel austenitic alloys require long (several minutes or more) heat treatment times to ensure homogenization due to the slow diffusion rates. Induction heat treating provides only a few seconds at temperature. It is interesting to note that ASTM specifications do not specify minimum heat treat times, even though they may be critical for corrosion resistance.

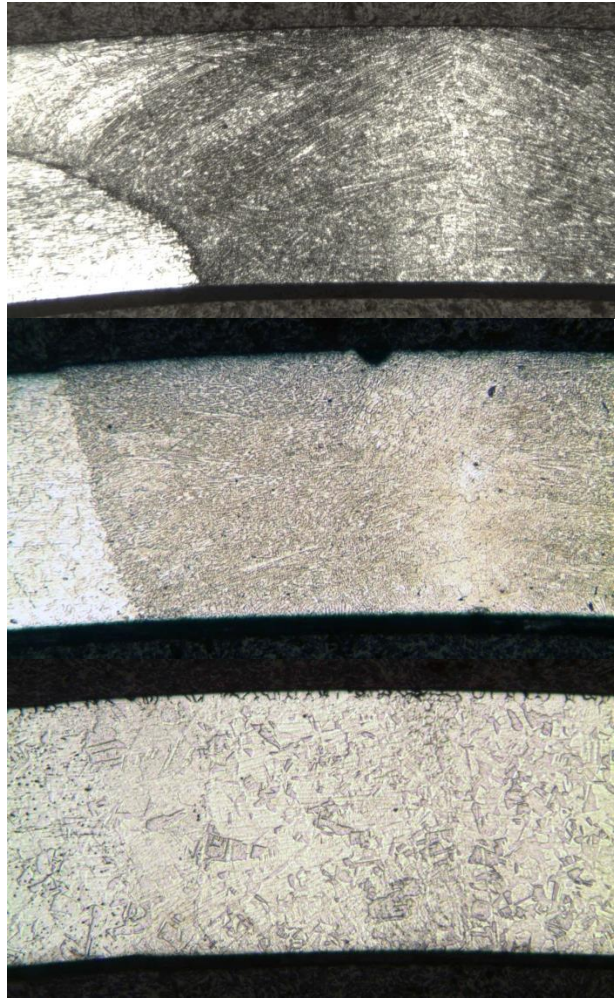
Figure 14. Three stages of a cold worked weld with additional processing. The top one is a weld with short term induction annealing only. Note that the dendritic cast structure is still apparent. The middle one is after a longer term furnace anneal. After one or more draw passes and furnace anneals, the weld on the bottom become very difficult to find.

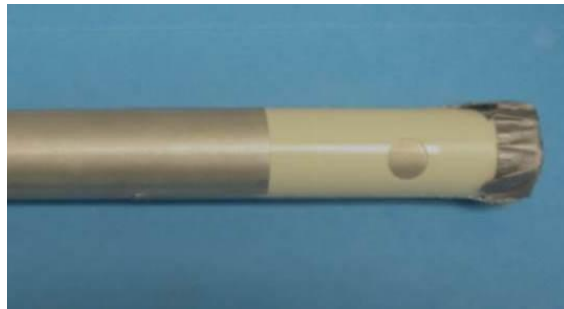
Figure 15 Schematic of the G61 test apparatus and a masked tube sample intended for OD testing.

Blessman and his team (Ref 7) reviewed a number of potential methods for examining the chloride resistance of 300 series stainless steel in search of a rapid repeatable and reliable method to identify good vs. inferior corrosion resistance. The test needed to examine the actual surface that was to be placed in service and test both the weld and base metal simultaneously. They came across the ASTM G61 test, and while searching for the appropriate media found one that had had some significant use in the pharmaceutical industry. To keep the test simple by running at room temperature, they identified that a bath prepared using 1000 ppm chloride acidified with HCl to a pH of 5 could provide the results that they were searching for. A schematic of the G61 apparatus and an example of a test sample are shown in Figure 15.

The sample is prepared by masking off the surface of the tube from the solution except for a 1 cm² area that includes both the weld and base metal. The sample can be modified to test either the ID surface or the OD surface, depending which one was the one of interest. Electrode potential was scanned in the more noble direction from -25 mV below open circuit potential until the current reached a value of 500 $\mu\text{A}/\text{cm}^2$. Critical Pitting Potential was defined as the potential where the current reaches a level of 100 $\mu\text{A}/\text{cm}^2$. To confirm that the method was effective, a number of internal samples with varied processing was prepared plus four additional commercially purchased samples were included in the examination.

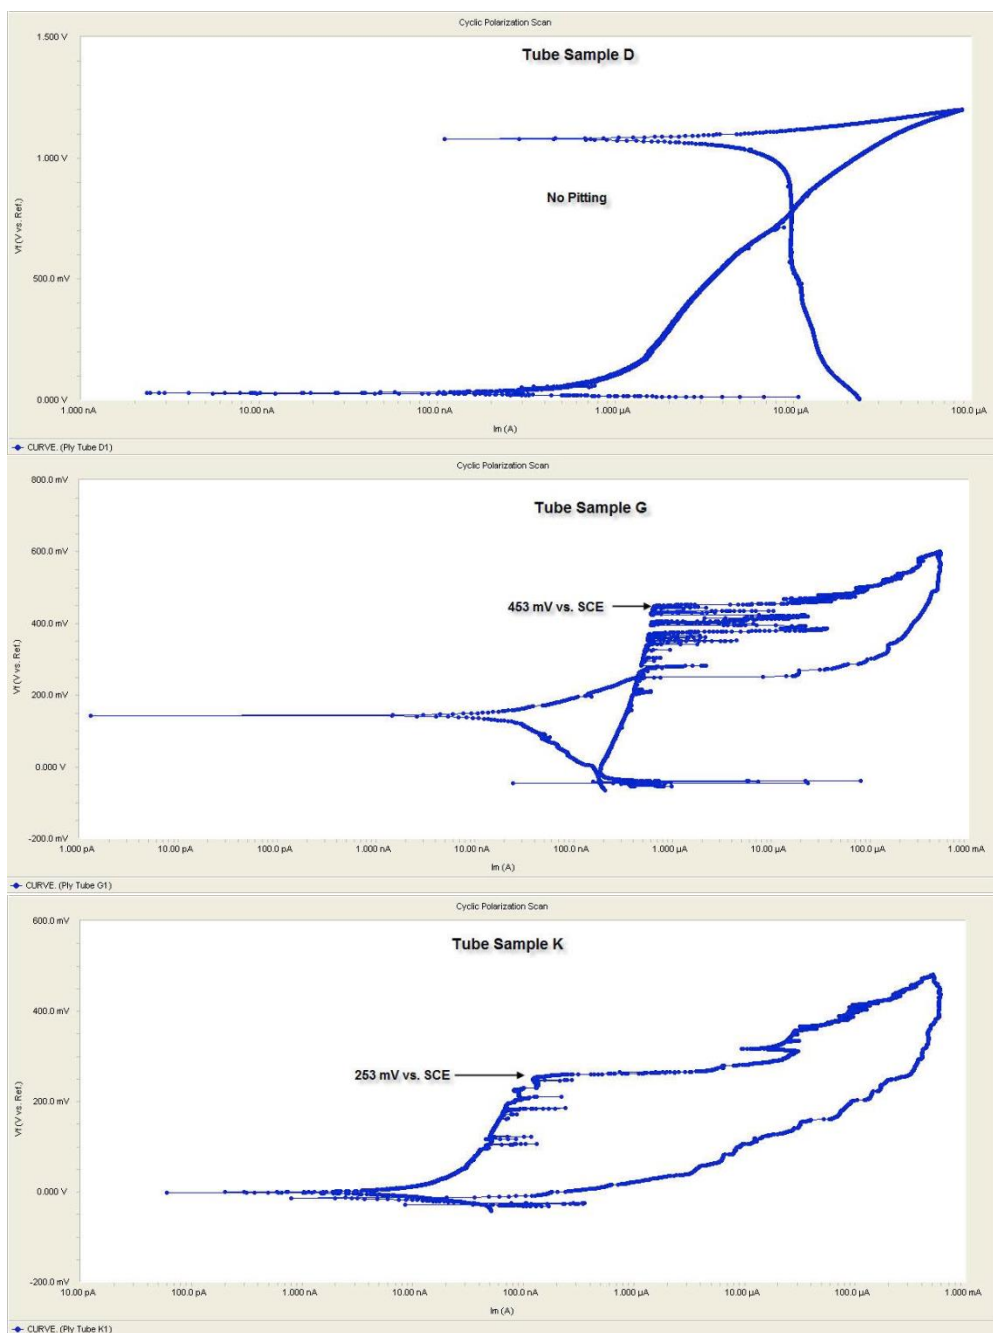
Figure 16. The top 2 G61 potentiodynamic scans are of samples D (304L) and G (316L) which were furnace annealed and in-line annealed respectively. The bottom scan was from sample K (316L) which had the lowest critical pitting potential of 253 mV. Note that the bottom axis of the lower two scans are extended to 1000 mA to show the entire scan.

Figure 16 shows the scans for Sample D (Furnace bright annealed 304L) and Sample G (Optimized in-line bright annealed 316L), and Sample K (304L with unknown heat treat history). The furnace annealed 304L made it to 1200 mv without pitting break down and had the highest critical pitting potential of all samples tested. The "ideal" in-line annealed 316L had a critical pitting potential of 453 mv, substantially lower than the 304L. As the welds were included in the test area, this drop is likely due to the greater inhomogeneity in the weld. The scan for sample K had the lowest critical pitting potential of all samples tested at 253 mv. Table 3 summarizes the results of all of the as-annealed samples. Blessman's paper also identifies that additional testing was done on pickled samples and only a few showed improvement.
