CONDENSER AND BOP EXCHANGER LAYUP- Do's and Don't's

39th Annual Electric Utility Chemistry Workshop

Dan Janikowski
Plymouth Tube

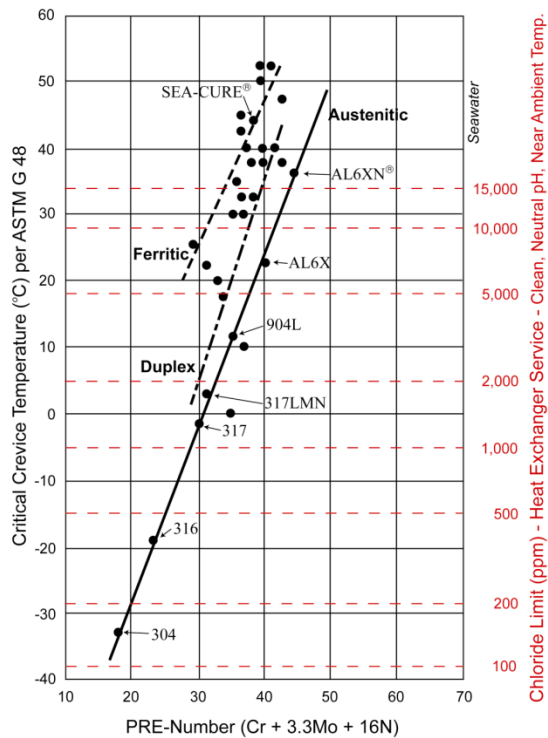
Figure 3. Relationship between chloride resistance, alloy content, and crystal structure of stainless steels.

The initiation of attack in stainless steels is more complicated. Kovach and Redmond (Reference 7) and Janikowski (Reference 8) have identified that the chloride resistance of stainless steels is not only a function of the alloy content (with Cr, Mo, and N being the principal alloy additions providing chloride resistance), the alloy crystal structure is also important (Figure 3).

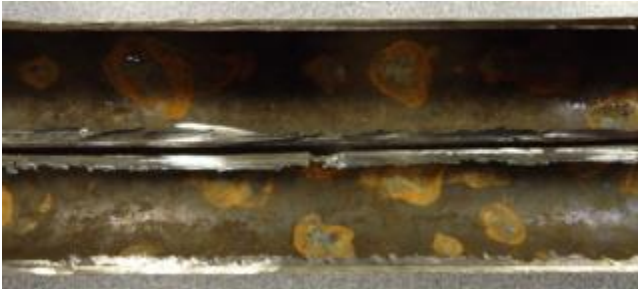
Figure 6. Attack on TP439 can be closely spaced multiple sites.

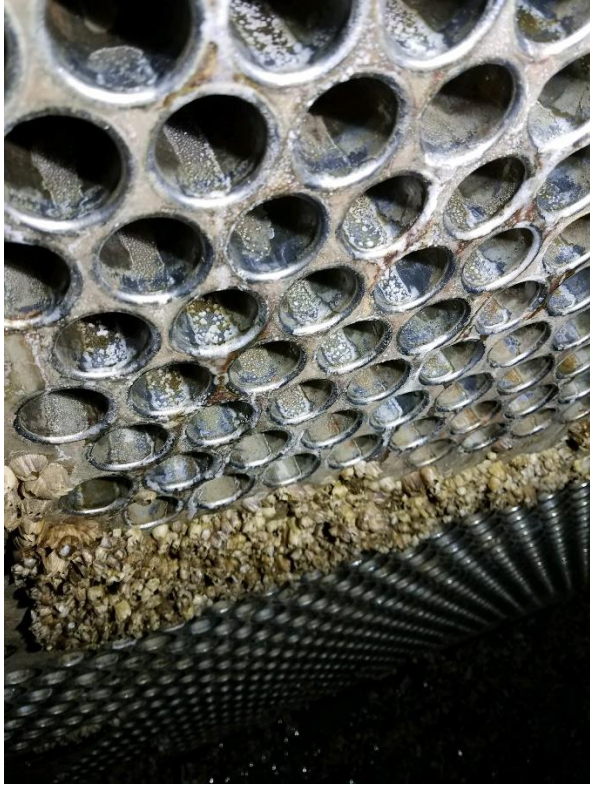
Figure 7. A combination of sea-salt crystals of tubes left to dry at the top and macrofouling at the water level on an improperly laid up seawater condenser bundle.

High performance alloys have little risk of pitting during shorter term unprepared lay-up in fresh or lower chloride waters. However, in longer term situations, deposits may build that could have a significant impact on thermal performance. The cost of the performance loss and subsequent cleaning should be evaluated and compared to the cost of an effective lay-up. In many cases, the cost of the lay-up is justified many times over. In Figure 7, a seawater tubesheet exhibits two issues for high performance alloys that are a concern. On the top half of the bundle, salt crystals are evident in each tube as seawater slowly dried in each tube. This action raises chloride levels

above the pitting threshold for the high-performance alloys in the paragraph above. Essentially, the condenser tubing is used for a crystallizer! Below this section was a level that shows the potential for macrofouling that can impact thermal performance upon start-up.
