# **Factors for Selecting Reliable Heat Exchanger Tube Materials**

**PRESENTED AT:**

**The 33<sup>rd</sup> Electric Utility Chemistry Workshop  
At The University of Illinois**

**Presented by:**

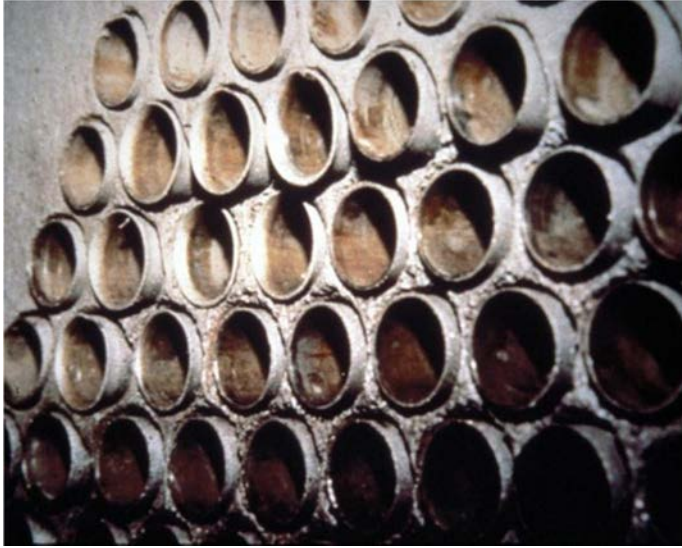
Figure 1. Galvanic attack of a carbon steel tubesheet in contact with stainless steel tubes in high conductivity water (courtesy of Plastocor)

Galvanic corrosion can occur when two different metals are electrically connected in a high conductivity electrolyte, such as water with some total dissolved solids. An example is shown in Figure 1.

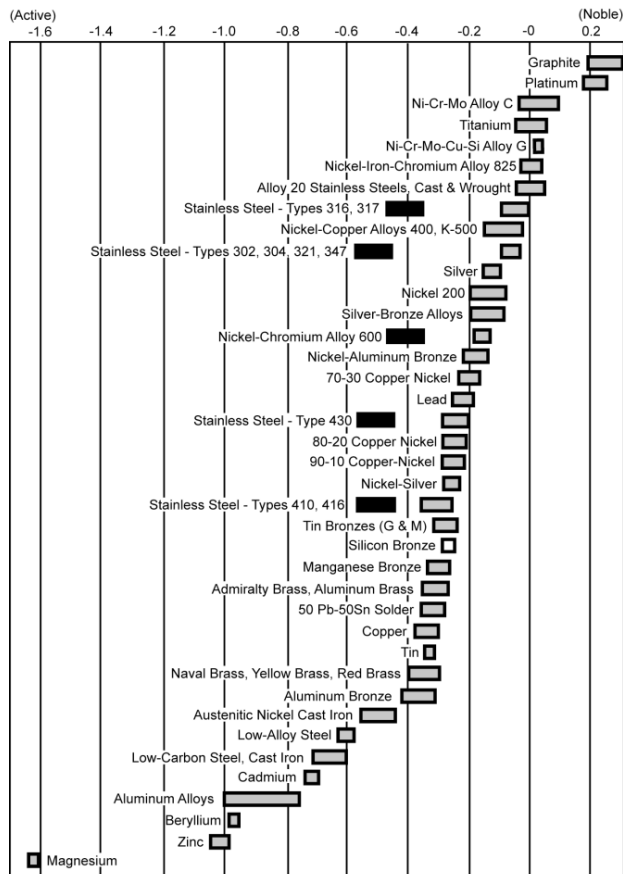
Figure 2. Galvanic Series in Seawater

One can predict whether this could happen by reviewing the chart called the galvanic series as seen in Figure 2. In this chart, the metals on the right are “noble” or corrosion resistant. Those on the left are “active” or are more readily corrodible. On the top axis is a listing of voltages that are generated when the metals are electrically connected in, in this case, seawater. These voltages can be different in other solutions. In this chart, the “zero” volt location is set using a Cu/ Cu sulfate reference electrode. When two metals are connected together, they generated a voltage equivalent to the difference at the top of the chart. For example, when Ti is connected to carbon steel in seawater, the cell will generate 0.6 V. The metal with the more negative potential will actively corrode while that with the more positive potential will be protected. This is the reason that the active metal is often called the sacrificial anode. As the voltage or the current increases, the corrosion rate of the active metal increases.

Note that in this version of the galvanic series, many of the stainless steels and a few nickel alloys are shown with boxes with two voltages. The gray filled boxes are the corrosion potential when the passive film is intact. However, when the passive film is removed and is unable to reform, the potential becomes more negative. The re-passivation can be prevented by a number of factors including, high chlorides, low pH, higher temperature, or changes in oxygen level. The two potentials in the same metal indicate that a cell can be formed without contact from a second metal this is what occurs in pitting corrosion or crevice corrosion.

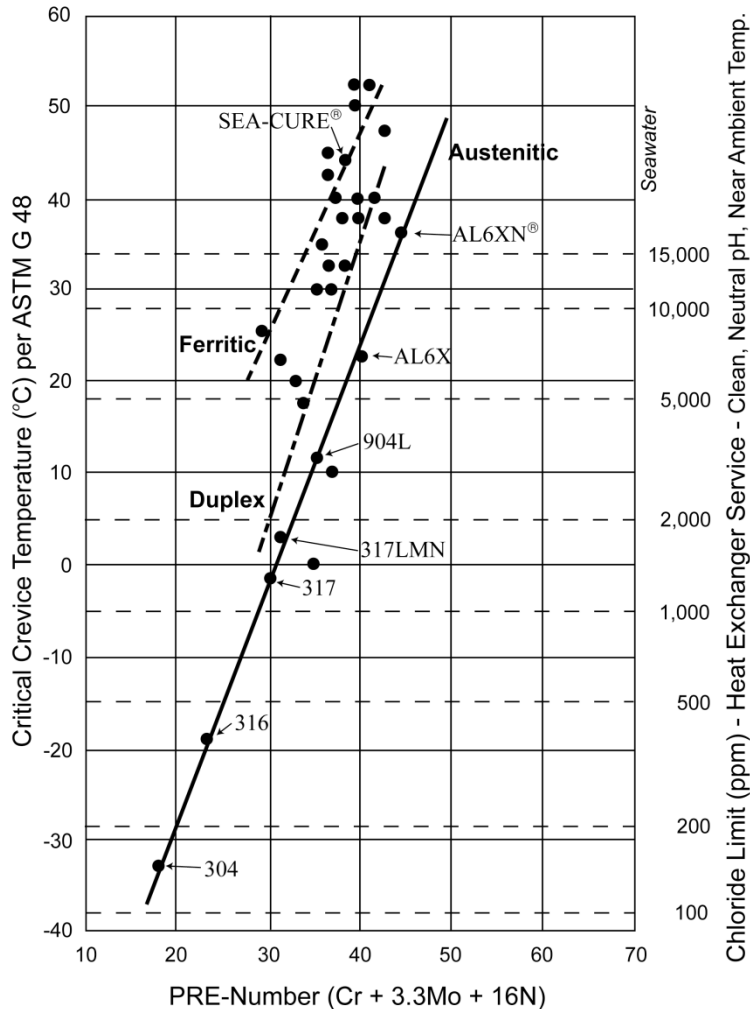
**Figure 3 Critical Crevice Temperature and Maximum Chloride Levels versus PREn of Various Stainless Steels**

Ferritic stainless steels were found to have the highest CCT for a particular PREn, above the duplex grade of the same PREn, followed by the austenitics. Each specific stainless structure provides a separate parallel linear correlation. After a typical or minimum chemistry is determined, the PREn can be calculated. To compare the corrosion resistance of two or more alloys, a line is drawn vertically from the calculated PREn for each alloy to the appropriate sloped line for the structure. The vertical line should stop at the bottom line for austenitics, such as TP 304, TP 316, TP 317, 904L, S31254, and N08367. Duplex grades, such as S32304, S32003, S33205, and S32750, fall on the center line. The G48 crevice corrosion results of the ferritics, such as S44660 and S44735, follow the top sloped line. From this intersection, a horizontal line should be drawn to the left axis to determine an estimated CCT. A higher CCT indicates more corrosion resistance.

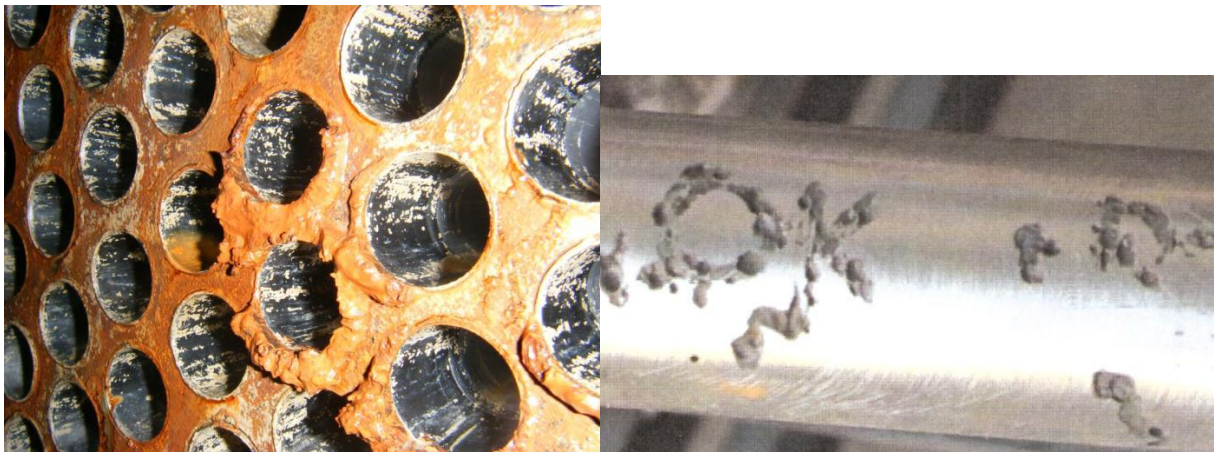
Figure 4. Two examples of unexpected crevice corrosion- the one on the left is of a 321 tube-to-tubesheet joint with S44660 tubes and that on the right is under paint in the shape of OK on a 416 stainless pump shaft

Figure 4. Tube-to-tubesheet crevice corrosion is becoming much more common as plants are being built with lesser expensive materials, the materials are becoming less corrosion resistant with alloy shaving, using more competitive (and less corrosion resistant) tube manufacturing methods (ref 5), and increase usage of more aggressive cooling water as traditional sources have become rare.

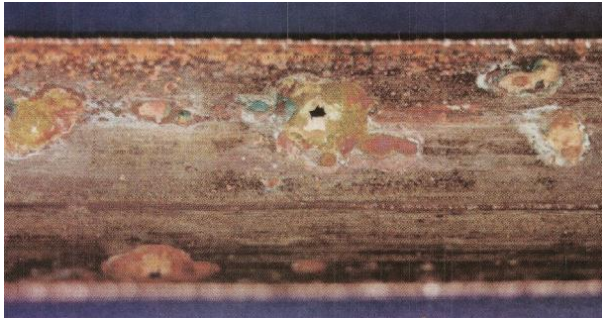
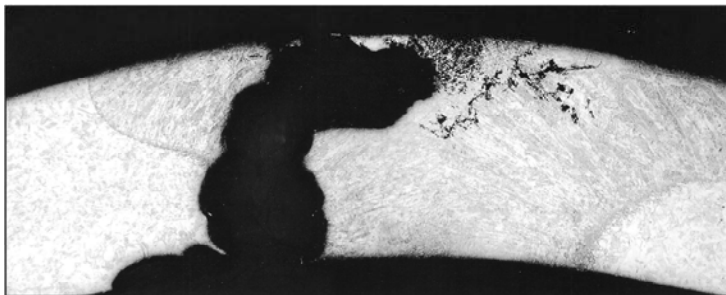
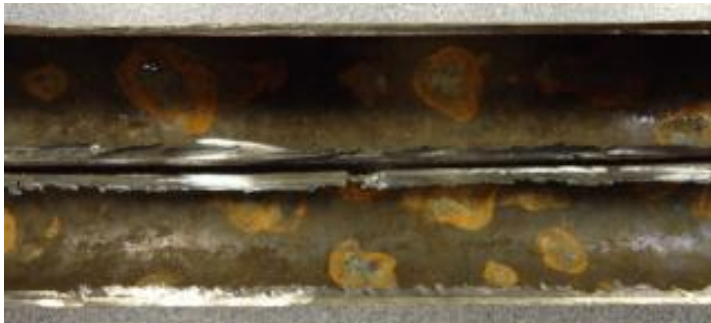
Figure 5 MIC attack of three different alloys – 90/10 Cu/Ni, Type 304 stainless steel, and Type 439 stainless steels. All of these occurred in less than 1 year after installation.

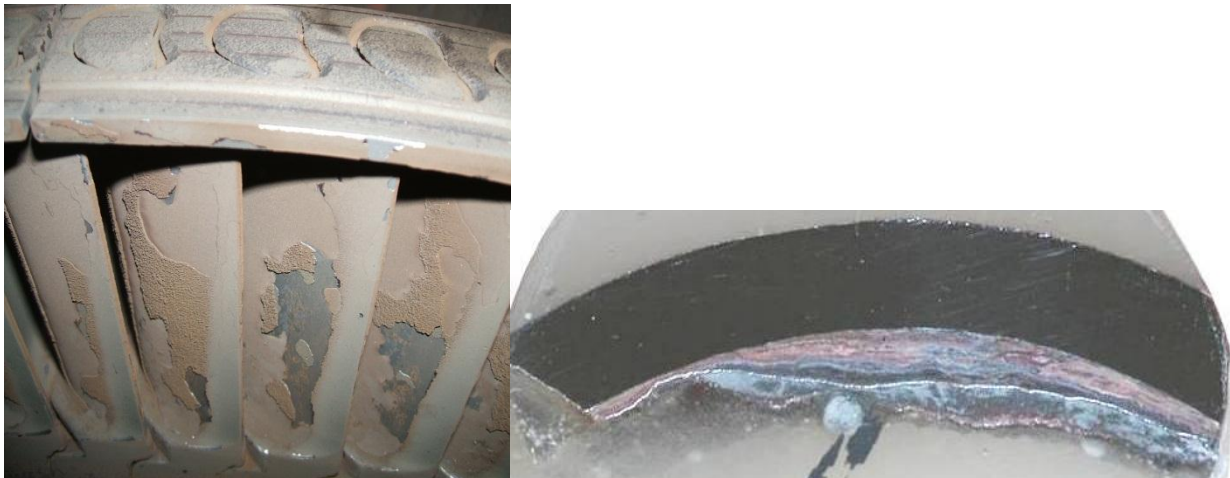
**Figure 6. Copper deposits on HP turbine at Pacificcorp Huntington Unit 2 and layered alternating iron and copper deposits on boiler tubes.(ref. 10)**

Once corrosion occurs, the metals can transport in the steam to plate on other components in the system. The two metals that are most common are Fe and Cu. It is very difficult to control the condensate chemistry to protect both the Fe and Cu at the same time as they have competing pH requirements (ref 8). The copper can deposit on the HP turbine blades or boiler tubes. When it deposits in the turbine (Figure 6), it can cause as much as 10% decrease in MW generation resulting in income losses of several million dollars per year (ref 9, 10), or on boiler tubes, resulting in premature failures due to liquid metal embrittlement.

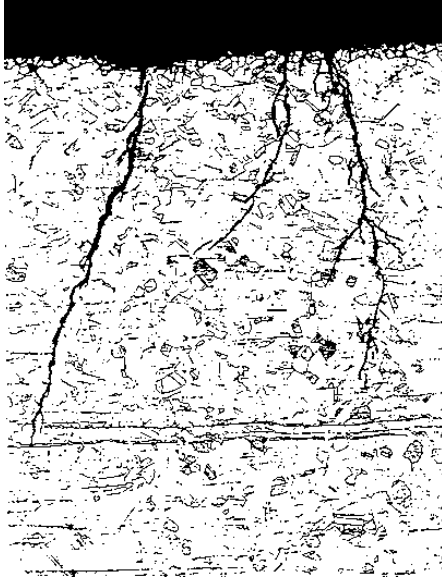
**Figure 7 Transgranular Stress Corrosion Cracking in TP 304N Feedwater Heater Tubing**

Stress corrosion cracking (SCC) is a rapid failure mechanism that can occur when a specific combination of conditions coexist. Figure 7 shows transgranular stress corrosion cracking in TP 304N feedwater heater tubing. This failure mechanism is identified from other brittle-type failures, such as fatigue, by the branching and secondary cracking. In 300 series stainless steels, it most usually occurs in the desuperheating zone of a feedwater heater, where conditions can concentrate chlorides.

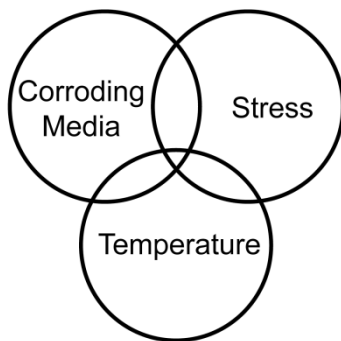
Corroding Media + Stress + Temperature

Copper Alloys - Ammonia  
Stainless Steels - Chlorides

**Figure 8 Three Factors Necessary for Stress Corrosion Cracking**

The three combined factors in Figure 8 needed to cause stress corrosion cracking of an alloy system: tensile stress, a specific corrodent, and a minimum threshold temperature. The stress we need to be concerned is a combination of all sources including residual stress, thermal induced stress, load applied stress (such as hoop stresses from the pressure inside the tube), and stress from other sources. Common sources of corroding media in the power industry include ammonia for the copper alloys and chlorides for the stainless steel alloys. A minimum threshold temperature is needed, below which the cracking will not occur. For example, chloride SCC in stainless steel steam surface condenser tubing is not a problem because the metal temperature is below the threshold.

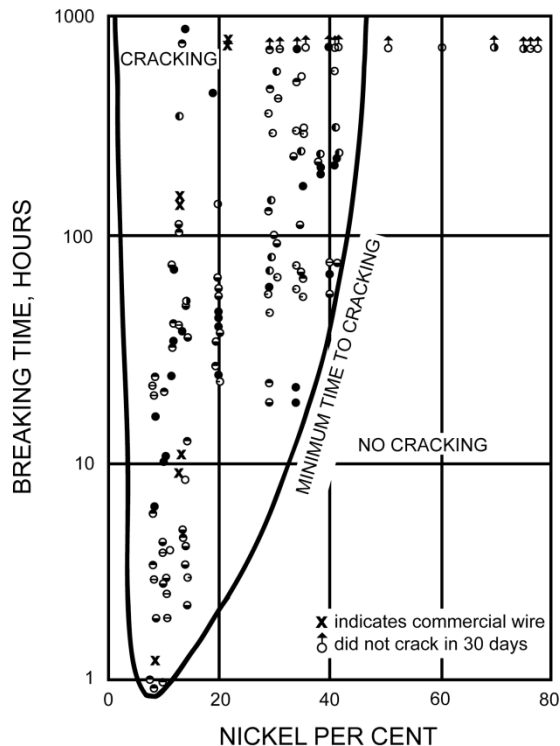
**Figure 9 Fracture time of stressed chromium, nickel, iron wires in boiling magnesium chloride – known as the Copson Curve**

stressed chromium, nickel, and iron wires in a boiling magnesium chloride bath, he was able to determine the effect of varying nickel content and cracking resistance. This is evident in Figure 9. The time to failure varied dramatically vs. nickel content. The stainless steel nickel content with the quickest failure was 8%, which is the same content of the workhorse of the industry, TP 304. TP 316, that has approximately 11% nickel content, is still very susceptible, as can be seen by the slightly higher time to failure. Improvements in time to failure come from selecting an alloy with very low nickel, or very high nickel, such as the 6% molybdenum containing alloys or alloy 800. TP 439, with a specified maximum nickel content of 0.5% has not been shown to fail from chloride stress corrosion cracking. The high nickel alternative can be very expensive. Surprisingly, this curve shows that non-austenitic alloys can crack!

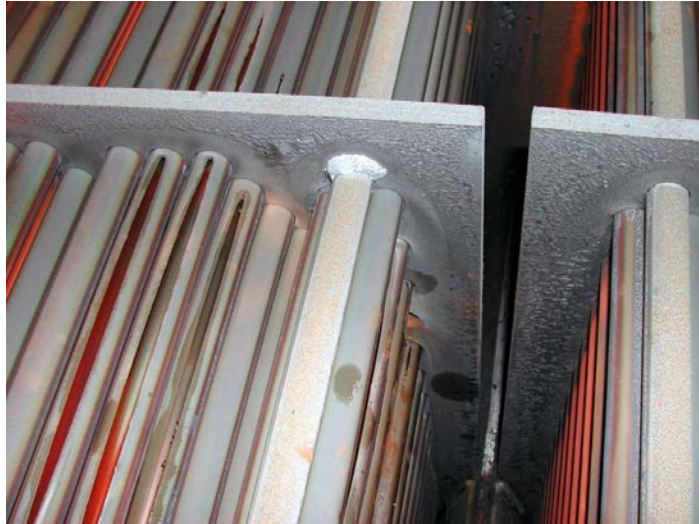
Figure 10. Water droplet steam erosion of titanium tubes in a nuclear plant on the East coast of the US.

In some specialized conditions, it is possible to experience erosion of the tube OD surface due to localized impact of high velocity water droplets (fig 10). This can occur near diverter plates that may focus steam velocity or during upset conditions. It often occurs in steam dump areas when the outlets are not properly designed. The resistance of this erosion is a direct function of the hardness of the metal substrate below the protective oxide. In general, higher hardness provides higher erosion resistance. Using a water droplet impingement device developed by Avesta Sheffield, alloys can be ranked by time to failure (ref. 12). By plotting hardness versus time to failure, a relationship can be

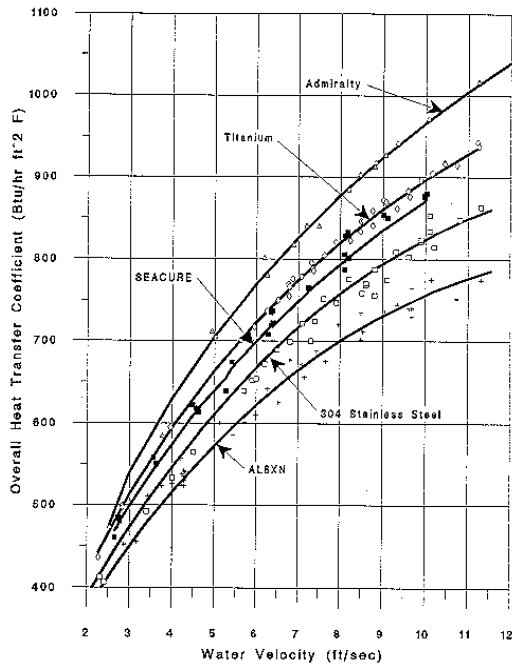
Figure 11 Heat Transfer coefficient for various alloys as tested by the Rochester Institute of Technology for HEI heat transfer coefficients.

Condensing studies done at Rochester Institute of Technology, used to develop heat transfer parameters for the HEI 9<sup>th</sup> Edition, show realistic differences between the alloys (ref. 13). The test results (Figure 11) are based upon new tubes, prior to the formation of oxides, scales, and slimes common after a few months of use. Once scales/patina deposits, the difference between the copper alloys and the stainless steels/titanium is less evident. In many cases, the stainless can be an advantageous selection. In condensing applications, copper alloys commonly develop steam side thermal barriers resulting from corrosion reactions with the chemicals normally added for oxygen control. This does not occur on stainless steels. The degradation of copper's overall conductivity gradually declines over the first year in fresh water service and even more quickly in sea and brackish water service (ref. 14). To account for this difference in condensing applications, the HEI method allows assignment of cleanliness factors for each application. The cleanliness factor chosen for unscaled copper alloys is typically 85%, while 90-95% is normally proven when stainless steels and titanium tubes are used.

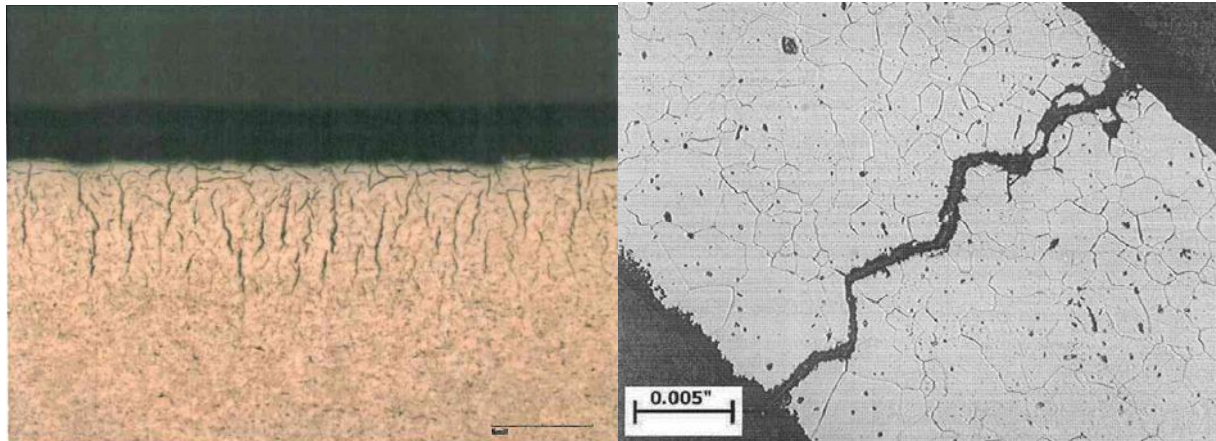
Figure 12 Titanium hydride acicular structure in Grade 2 condenser tubing on left side. Hydrogen driven crack in S44735 on right. The crack mechanism is commonly transgranular near the surfaces and intergranular in the mid-section.

Embrittlement of titanium occurs as a hydride second phase forms starting at the surface in contact with hydrogen. These are needle-like as can be seen in Figure 12. This layer grows with exposure and eventually the progresses through the entire wall. These embrittled tubes have little mechanical strength. Tubes can be broken simply by leaning on them. The process in titanium is not reversible.

discharging may create microcracking. Once this occurs, the tubing is no longer dependable. The S44735 shown on the right side of Figure 12 had been charged multiple times and finally cracked.

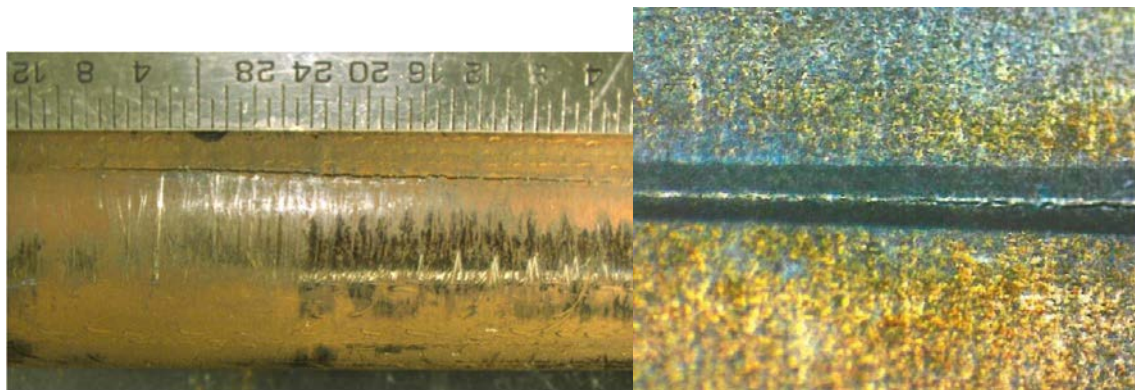
Figure 13 Longitudinal OD crack initiating on an OD installation scratch (left side) and a longitudinal ID crack initiating on an ID groove produced from an ID cleaning tool (ref 19, 20)

Unheard of 5 years ago, a number of longitudinal cracks in titanium tubing have been reported in the last few years (ref 19, 20). These all initiated on longitudinal stress concentrators such as OD scratches, ID grooves, or weld depressions. Some examples are shown in Figure 13.

All of the known longitudinal cracks occurred mid-span suggesting that fatigue had a major role in the cause. They have occurred as soon as 2 years after the cleaning incident or as long as 25 years after the tube installation. Surprisingly, they are randomly scattered throughout the bundles and in regions where steam velocities are far from the maximum. Scanning electron microscopy of some of these failures show fatigue striations confirming that vibration was a component of the failure.
